# Bathymetric Surveys at Highway Bridges Crossing the Missouri and Mississippi Rivers near St. Louis, Missouri, 2010

Scientific Investigations Report 2011–5170

By Richard J. Huizinga

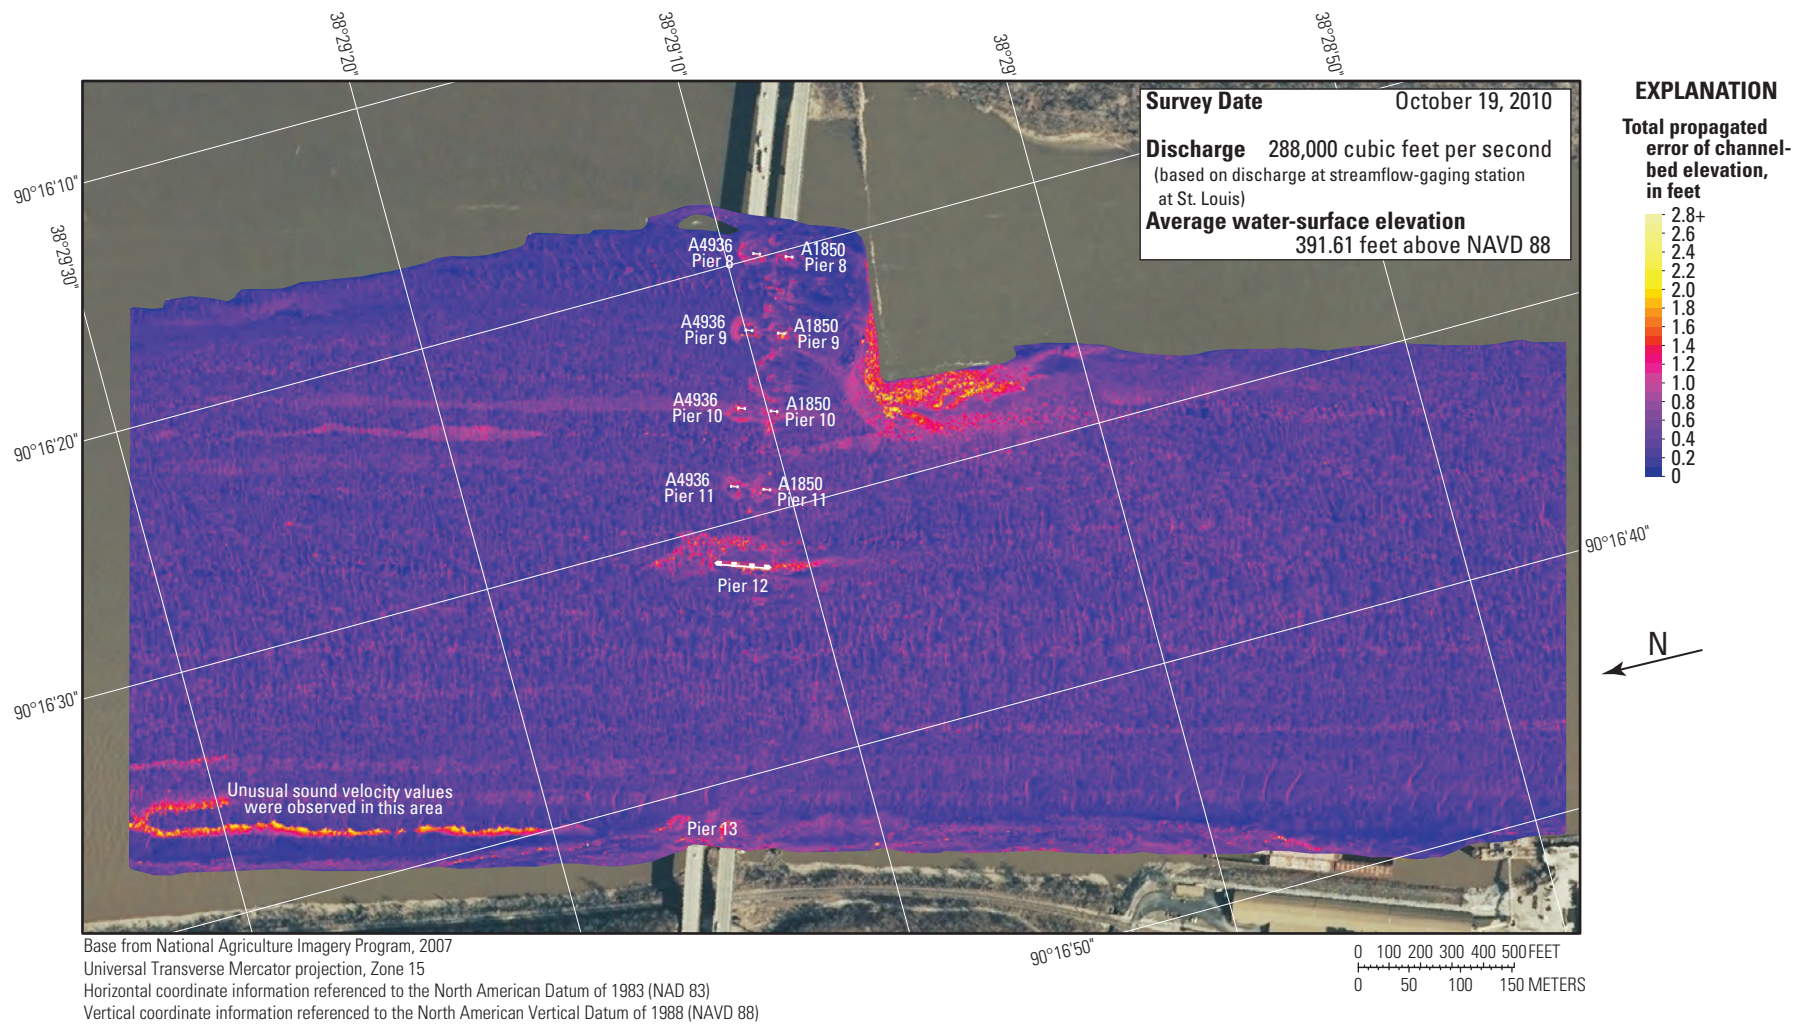
The largest TPE in the St. Louis surveys was about 5.5 ft (table 4); however, TPE values of this magnitude typically occurred near high-relief features, such as the front or side of a pier footing or large submerged object (fig. 3). A vast majority (over 99.5 percent) of TPE values were less than 1.6 ft (table 4), with larger values occurring near moderate-relief features (banks, dune faces, rock dikes, and scour holes; fig. 3). Occasionally, these larger TPE values also occurred in the outermost beam parts of the multibeam swath in the overlap with an adjacent swath, typically in the channel thalweg where substantial bed movement would occur between survey passes, or—particularly in the case of structures A4936 and A1850—in areas where sound velocity values were observed to be unusual (fig. 3). Substantial parts (approximately 80 percent or more) of the channel bed at all of the surveyed sites had TPE values of 0.5 ft or less, and over half of the bathymetry data had a TPE value of 0.33 ft or less (table 4). The tops of bridge substructural elements (pier footings and seal courses) typically had TPE values of 0.2 ft or less.

**Figure 3.** Total propagated error of bathymetric data from the Mississippi River channel in the vicinity of structures A4936 and A1850 on Interstate 255 near St. Louis, Missouri.

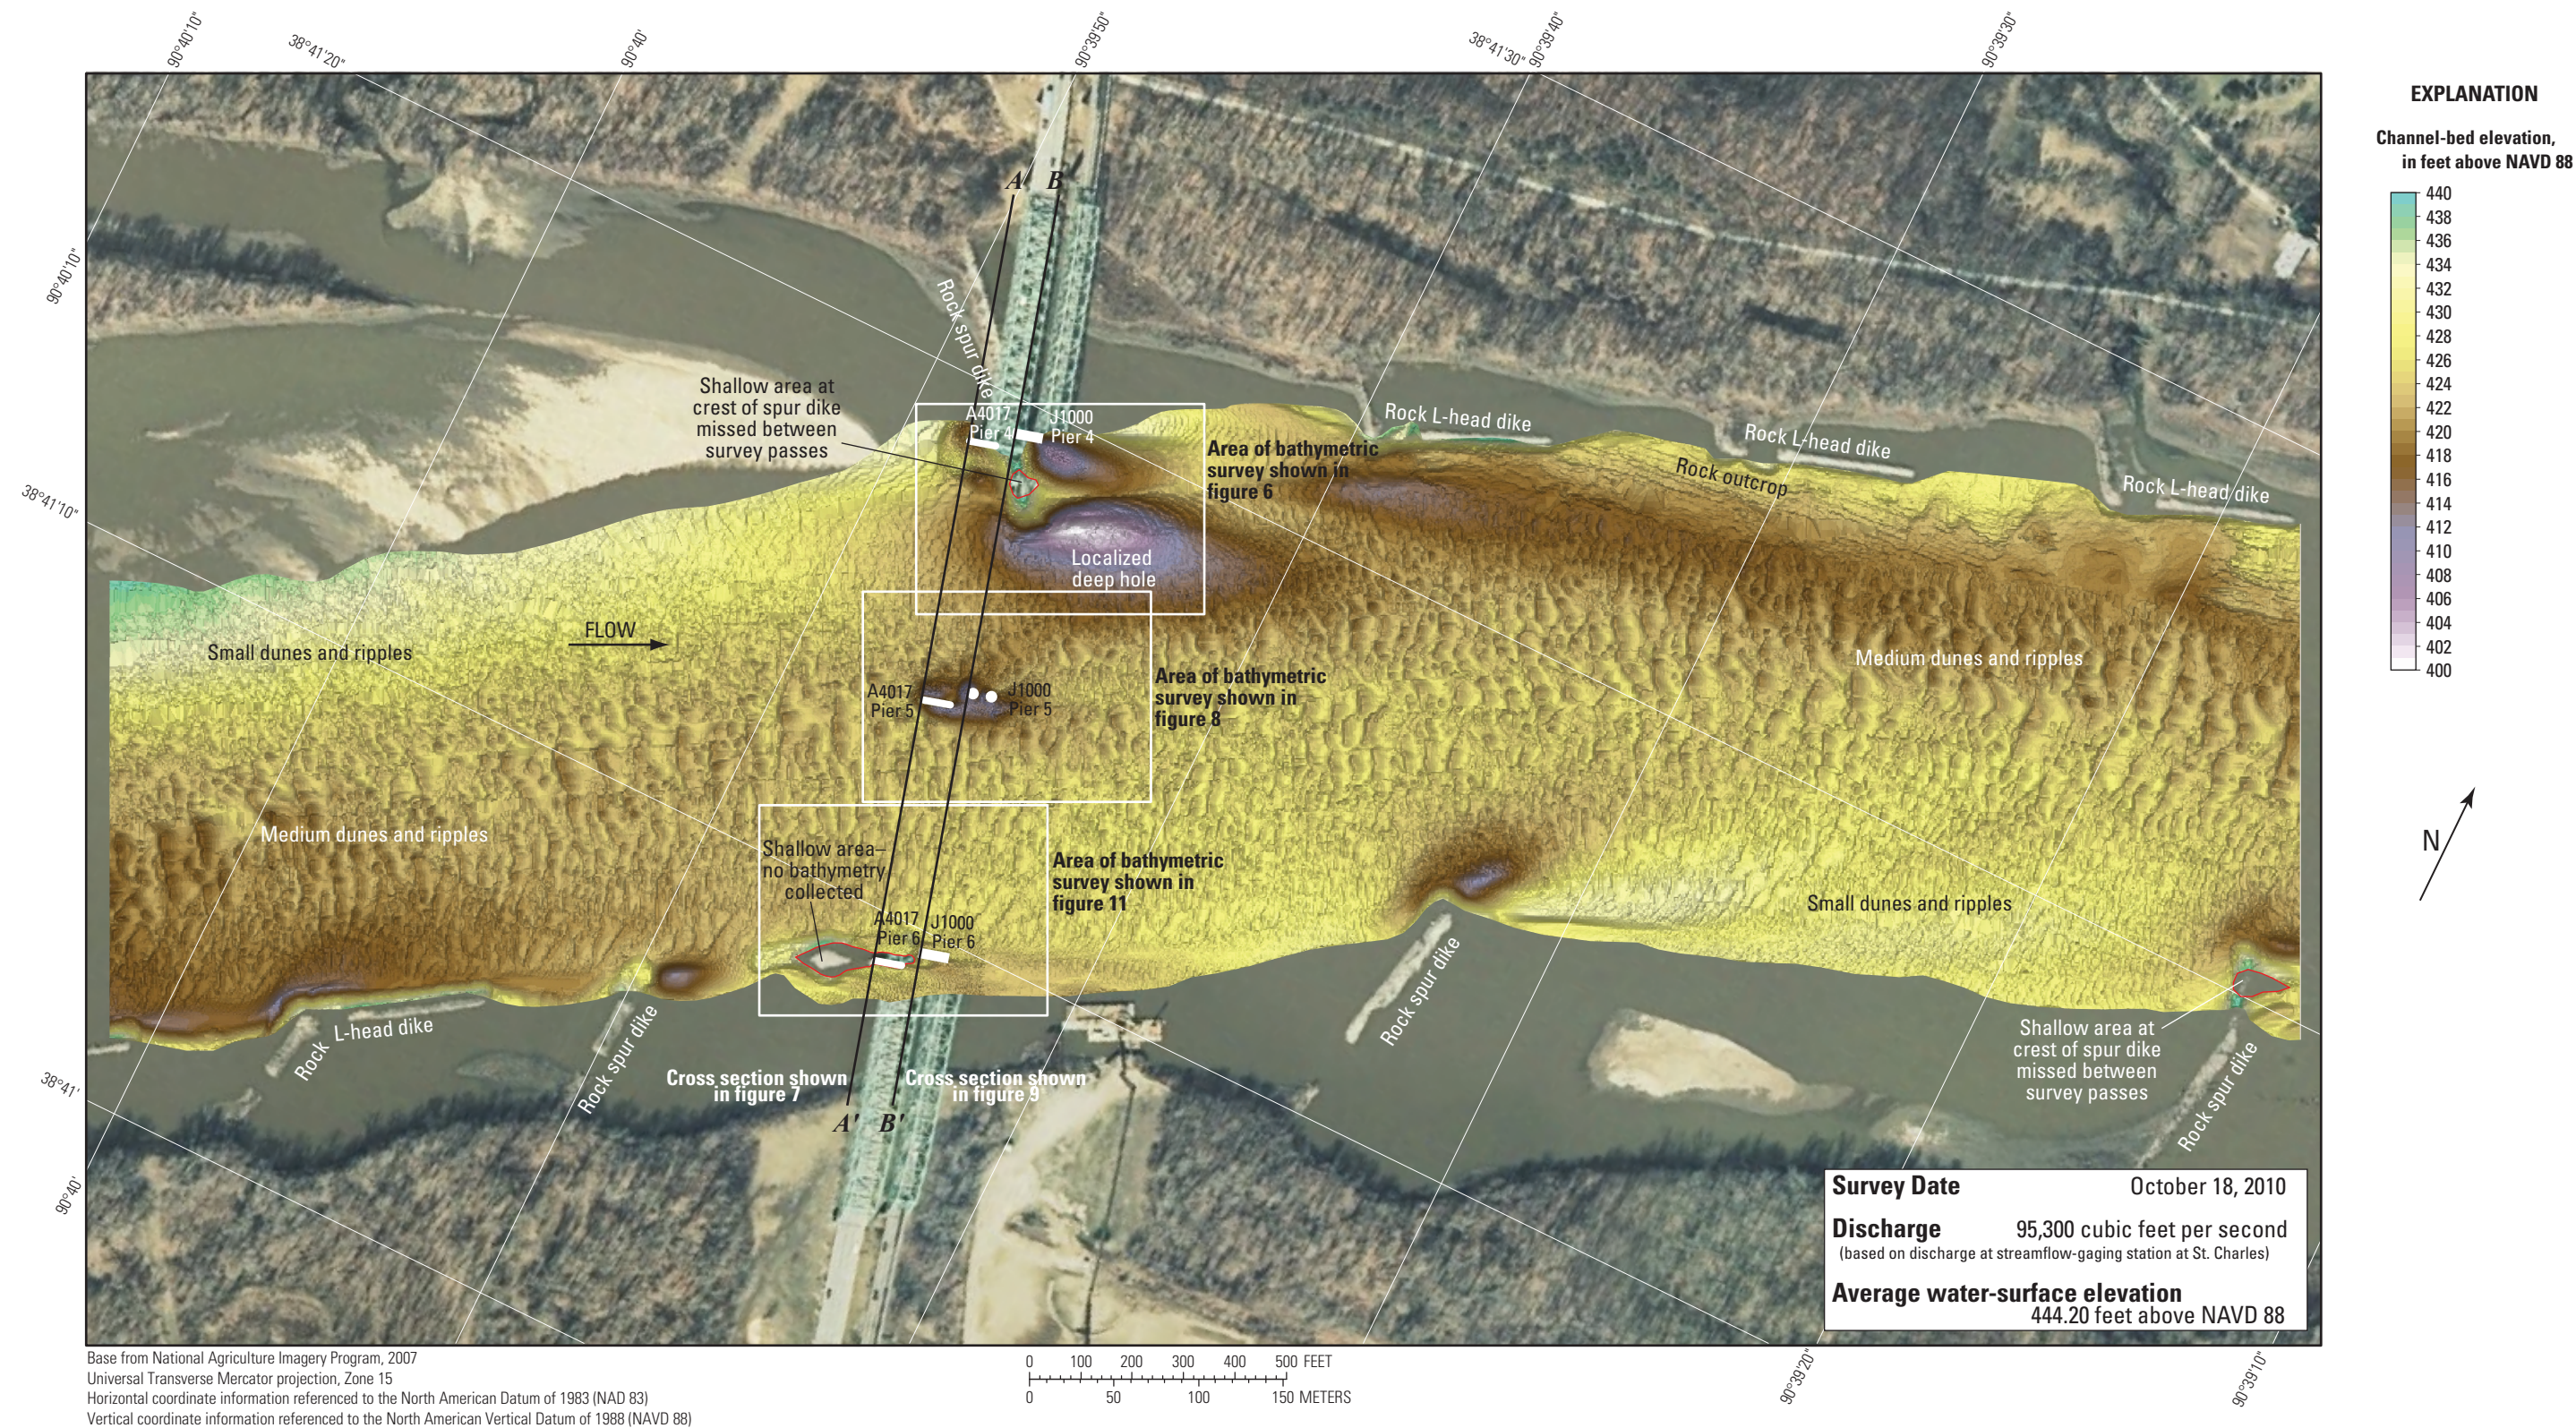
430 ft for most of the surveyed area (5 to 95 percentile range of the bathymetric data), except near the main channel piers of structures A4017 and J1000, and near the ends of various spur dikes (fig. 5), especially near the left main channel piers (fig. 6). A thalweg on the right (south) bank on the upstream end of the surveyed area was about 5 ft deeper than the channel bed in the middle of the channel (fig. 5). The thalweg became shallower and shifted to the middle of the channel at the bridges, and continued to shift to the left side and became deeper downstream from the bridges (fig. 5). Medium dunes and ripples were detected in the middle of the channel, with small dunes and ripples being detected in the shallow areas between spur dikes and on the left side of the channel in the upstream reach (fig. 5). A rock outcrop is present on the left (north) bank in the reach downstream from the bridges (fig. 5).

Figure 5. Bathymetric survey of the Missouri River channel in the vicinity of structures A4017 and J1000 on U.S. Highway 40 near St. Louis, Missouri.

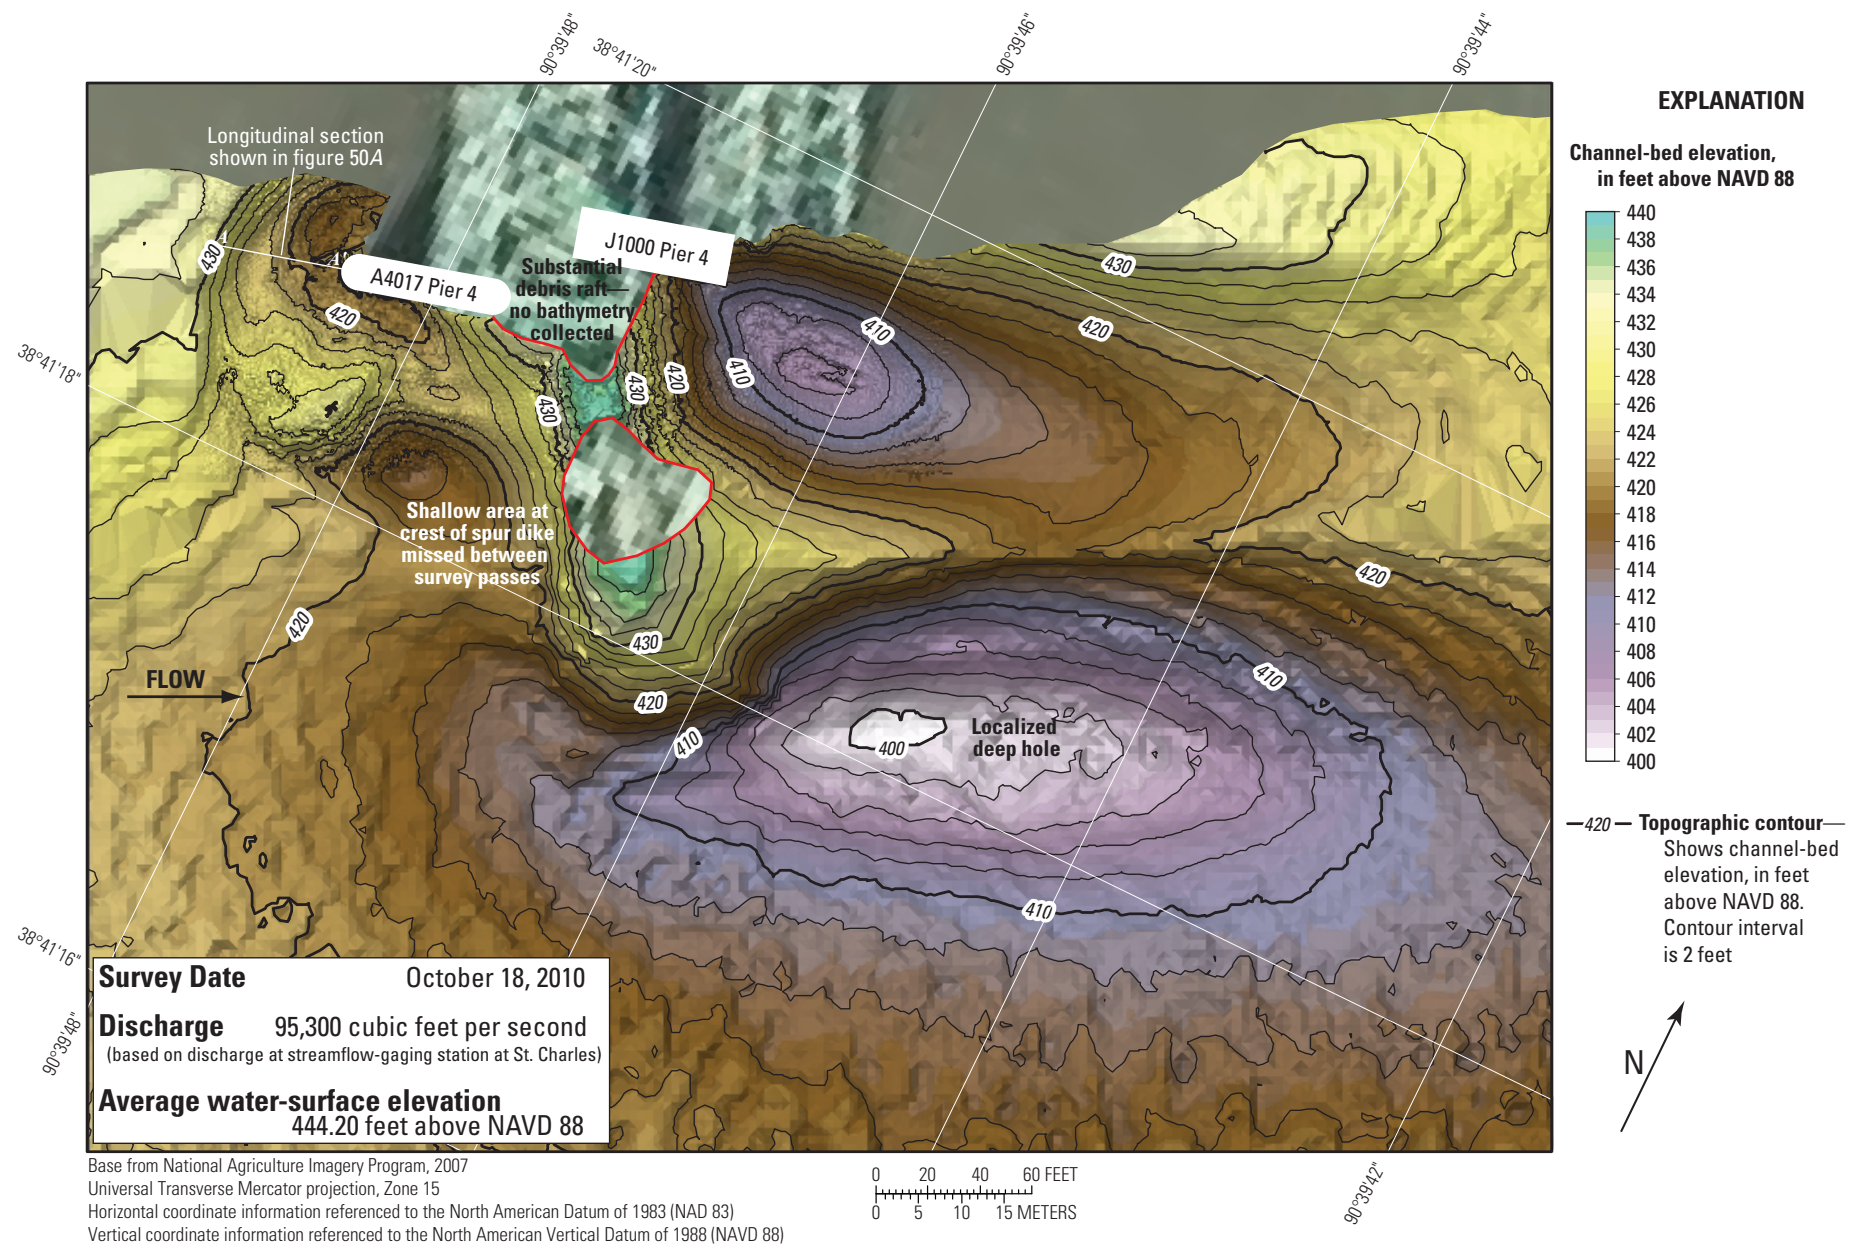
In the vicinity of the left main channel piers (pier 4 at both structures, fig. 6), a localized deep scour hole at the end of the spur dike had a minimum elevation of about 400 ft. A substantial debris raft at the nose of pier 4 of downstream structure J1000 and the presence of the spur dike made it impossible to acquire bathymetry data in the area upstream from that pier. At the upstream nose of pier 4 of upstream structure A4017, a local scour hole had a minimum elevation of approximately 416 ft (table 6), about 14 ft below the average channel bed immediately upstream from the pier, but well above the bottom of the footing elevation of 405.10 ft (fig. 7). Downstream from pier 4 of downstream structure J1000, another localized deep scour hole had a minimum elevation of about 406 ft (fig. 6), which exposes the downstream right corner of the caisson of that pier. Information from bridge plans indicates that pier 4 of structure A4017 is founded on footings on bedrock, with about 13 ft of bed material between the bottom of the upstream scour hole and bedrock at the upstream pier (fig. 7; table 6). Pier 4 of structure J1000 is founded on a caisson on bedrock, and the bottom of the local scour hole downstream from this pier is only about 2 ft above the bottom of the caisson and bedrock (table 6). However, the local scour hole likely is the result of flow over the spur dike, and not directly caused by the pier, and the downstream pier essentially is embedded in the rock of the dike, which will limit or prevent additional scour near both left main channel piers and minimize the effect of the local scour hole on the stability of the piers.

**Figure 6.** Bathymetric survey of the Missouri River channel in the vicinity of the left main channel piers of structures A4017 and J1000 on U.S. Highway 40 near St. Louis, Missouri.

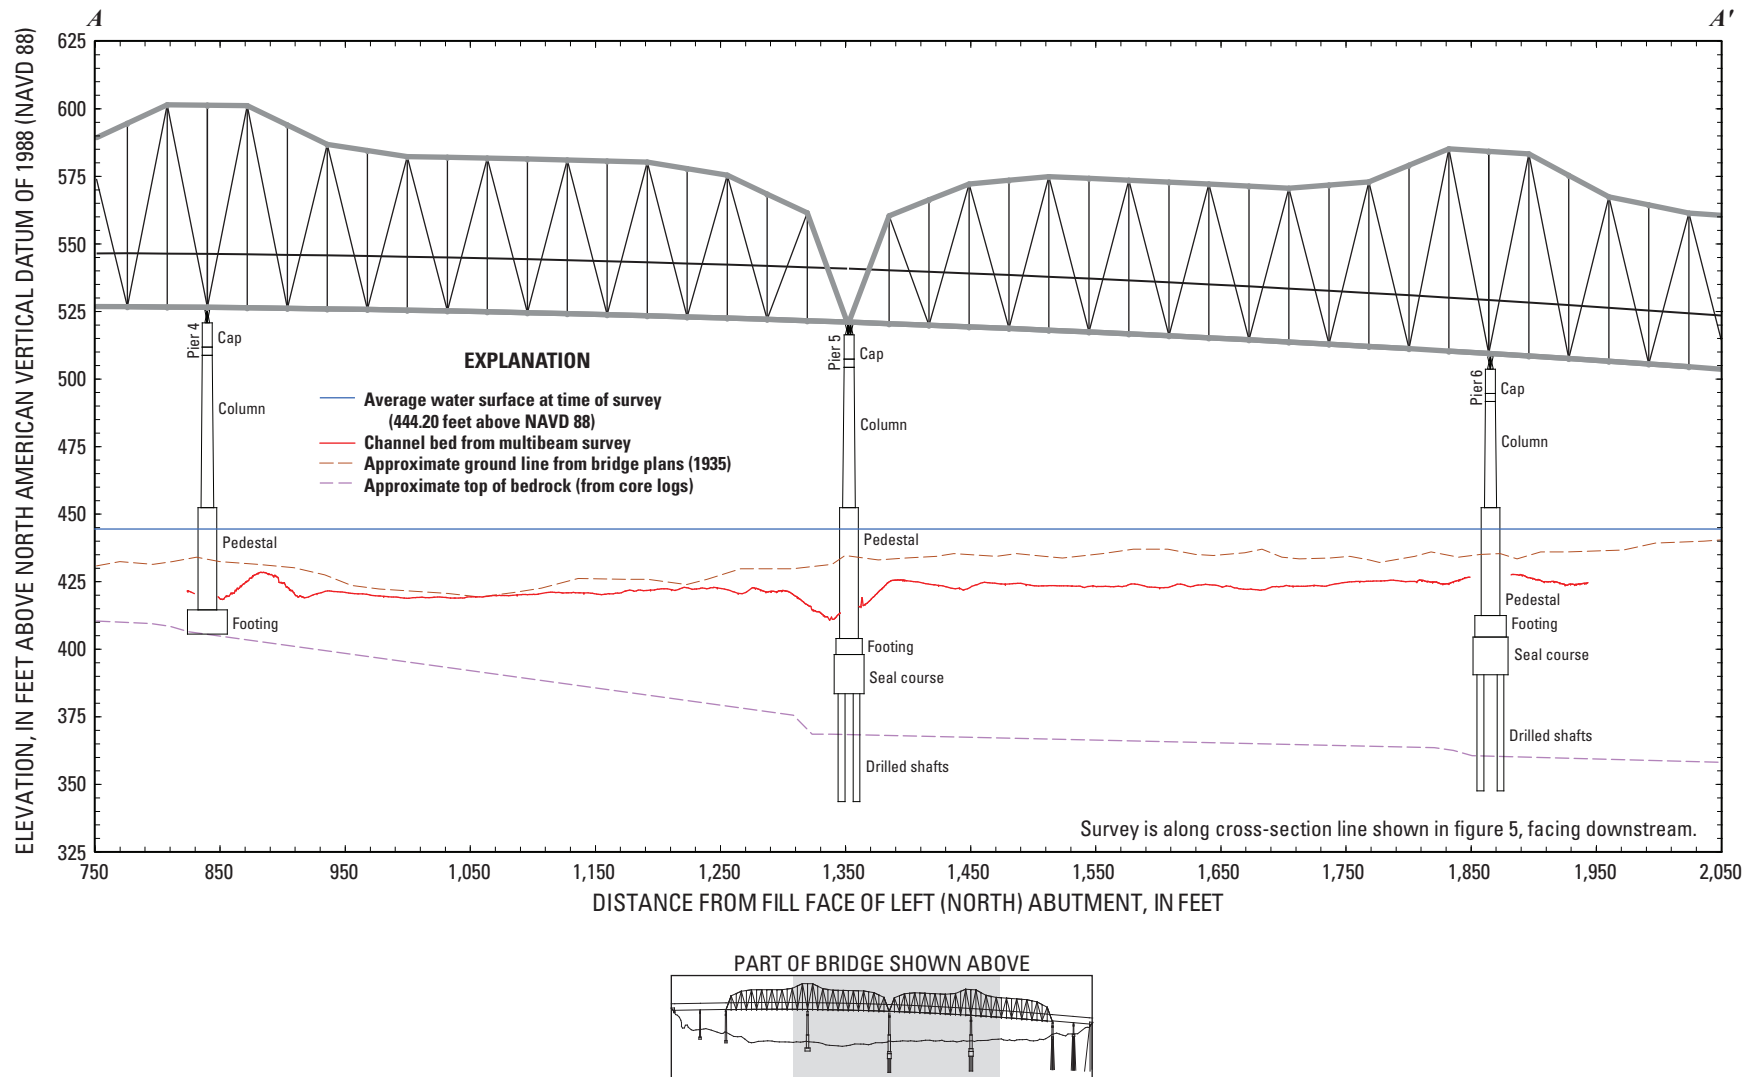
**Figure 7.** Key features, substructural and superstructural details, and surveyed channel bed of structure A4017 on U.S. Highway 40 over the Missouri River near St. Louis, Missouri.

The surveyed bed is approximately 10 ft lower than the original ground line from bridge plans at the time of construction (1985) at upstream structure A4017 between the central and right main channel piers (piers 5 and 6; fig. 7). The surveyed bed is approximately 16 ft lower than the original ground line from bridge plans at construction (1935) at downstream structure J1000 throughout much of the channel (fig. 9). These changes in bed elevation indicate a decrease in the overall bed elevation at this site with time.

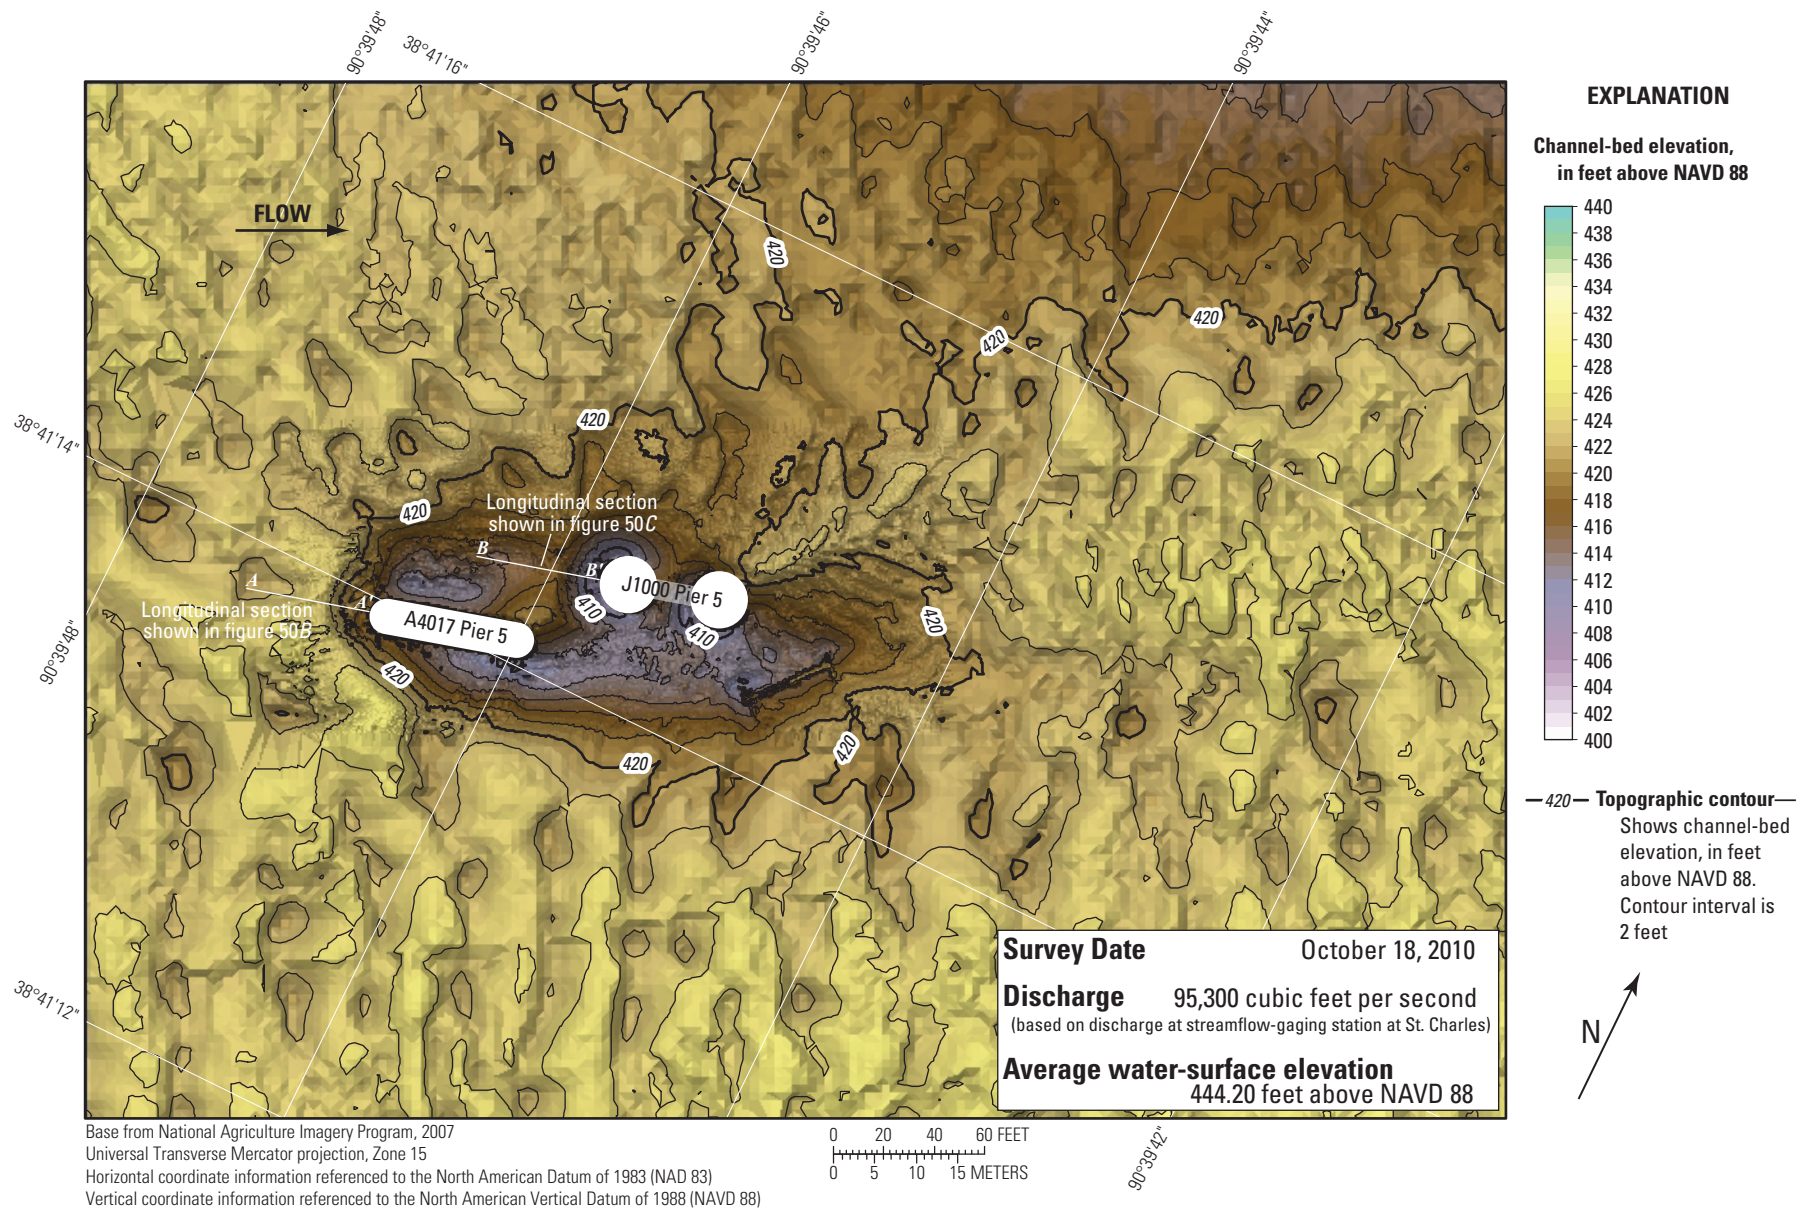
**Figure 8.** Bathymetric survey of the Missouri River channel in the vicinity of the central main channel piers of structures A4017 and J1000 on U.S. Highway 40 near St. Louis, Missouri.

In the vicinity of the central main channel piers (pier 5 at both structures, fig. 8), a local scour hole had a minimum elevation of approximately 408 ft (table 6), about 14 ft below the average channel bed immediately upstream from the piers, but well above the bottom of the seal course elevation (383 ft) of the upstream pier (figs. 7, 9; table 6); however, the local scour hole has exposed the upper part of the caissons of the downstream pier (figs. 8, 9). The central main channel piers were skewed to approach flow, which caused a wider scour hole with somewhat unique characteristics as compared to the scour hole of an unskewed pier. On the right

(south) side of the upstream pier, the scour hole was slightly deeper, and extended beyond the downstream pier caissons, whereas the leeward left (north) side of both piers had a local ridge of deposition (fig. 8). The deposition downstream from the upstream pier was eroded by the scour hole that formed upstream from the downstream pier caissons (fig. 8). Information from bridge plans indicates that pier 5 of upstream structure A4017 is founded on shafts drilled 26 ft into bedrock, with about 48 ft of bed material between the bottom of the scour hole and bedrock (fig. 7; table 6). Pier 5 of structure J1000 is founded on caissons on bedrock, with about 41 ft of bed material between the bottom of the scour hole and bedrock (fig. 9; table 6). A point cloud visualization of the multibeam depth points obtained during the survey clearly show the exposed caissons of the downstream pier (fig. 10).

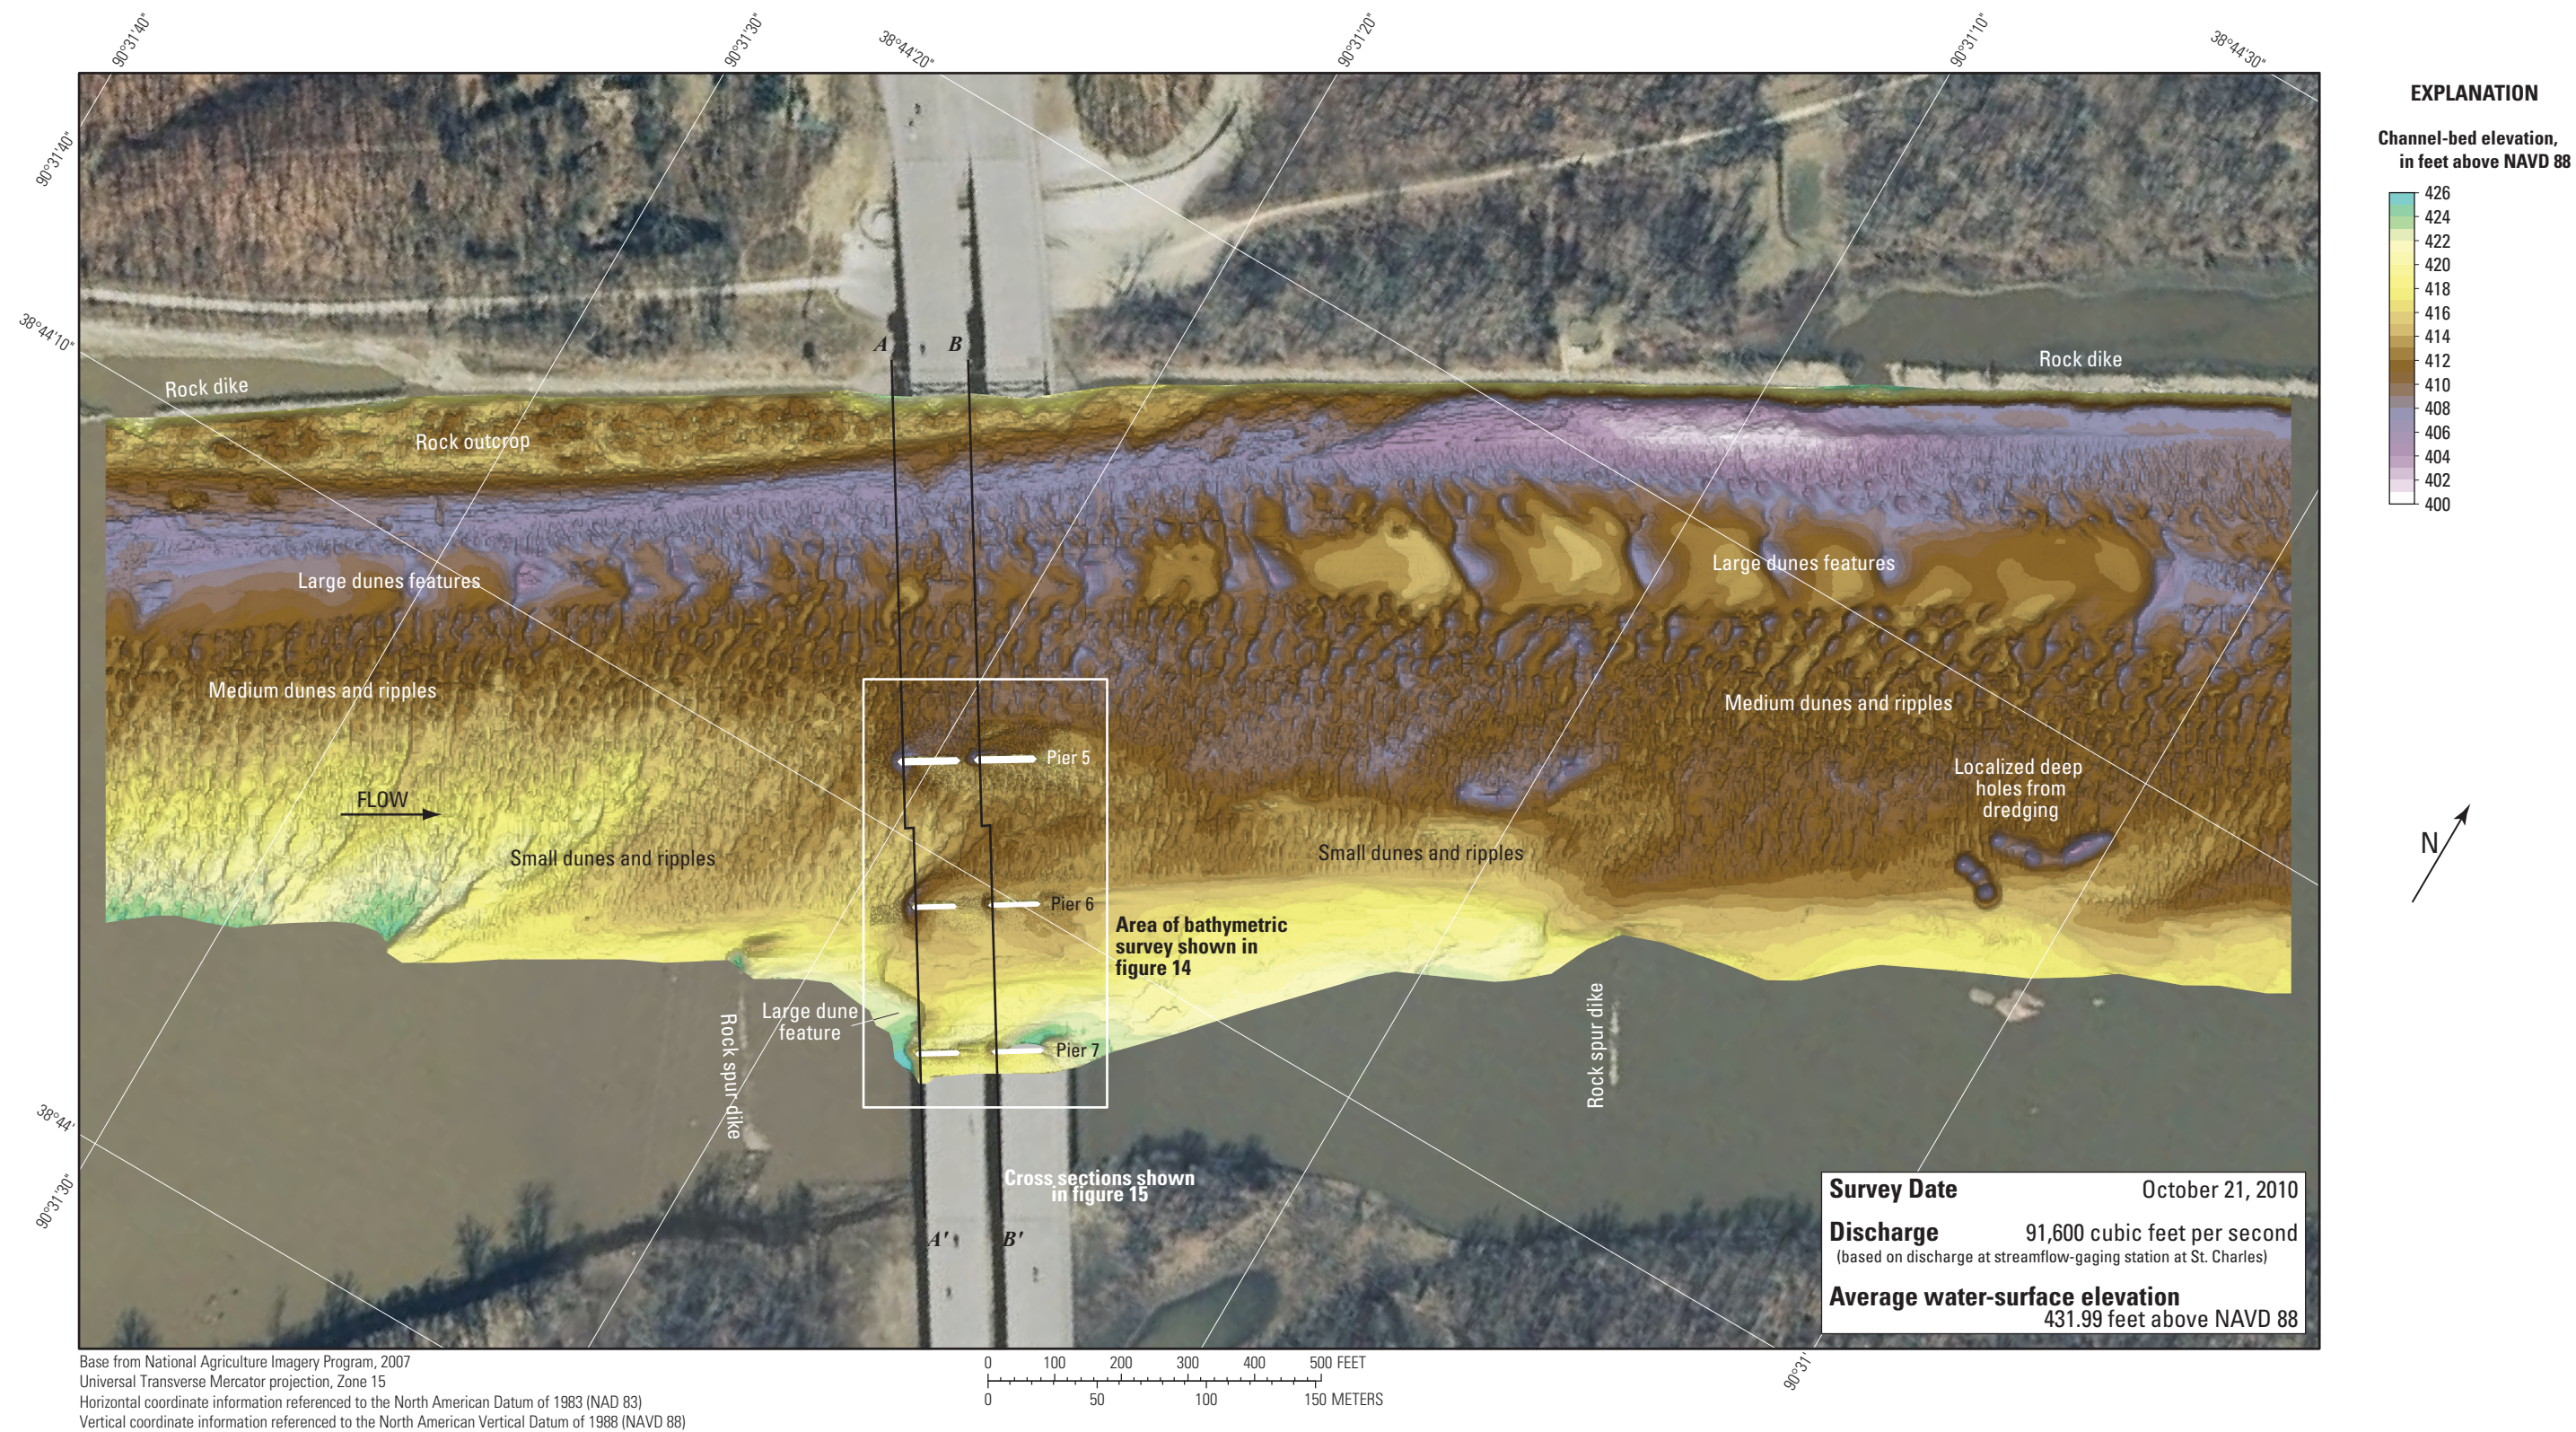
The survey area was about 3,280 ft long and averaged about 880 ft wide, extending from rock dikes and the channel bank on the left to shallow areas on the right in the main channel (fig. 13). The upstream end of the survey area was about 1,310 ft upstream from the centerline of structure A5585 (figs. 12, 13). The channel-bed elevations ranged from about 407 to 421 ft for most of the surveyed area (5 to 95 percentile range of the bathymetric data), except for a shallow area in the upstream right part of the channel. A narrow thalweg along the outside of the river bend on the left (north) bank was about 5 to 10 ft deeper than the channel bed in the middle of the channel (fig. 13). Between the rock spur dikes on the right (south) side of the channel, deposits reached an elevation of about 426 ft (fig. 13). Dredging operations of a dredge barge moored downstream from the bridges caused several localized deep holes in the channel bed (fig. 13). A series of large dune features were detected in the left side of the middle of the channel, which appeared to be washing over the numerous medium and small dunes and ripples throughout the rest of the channel (fig. 13). A rock outcrop is present on the left (north) bank in the reach extending from upstream to just downstream from the bridges (fig. 13).

Figure 13. Bathymetric survey of the Missouri River channel in the vicinity of dual bridge structure A5585 on State Highway 364 near St. Louis, Missouri.

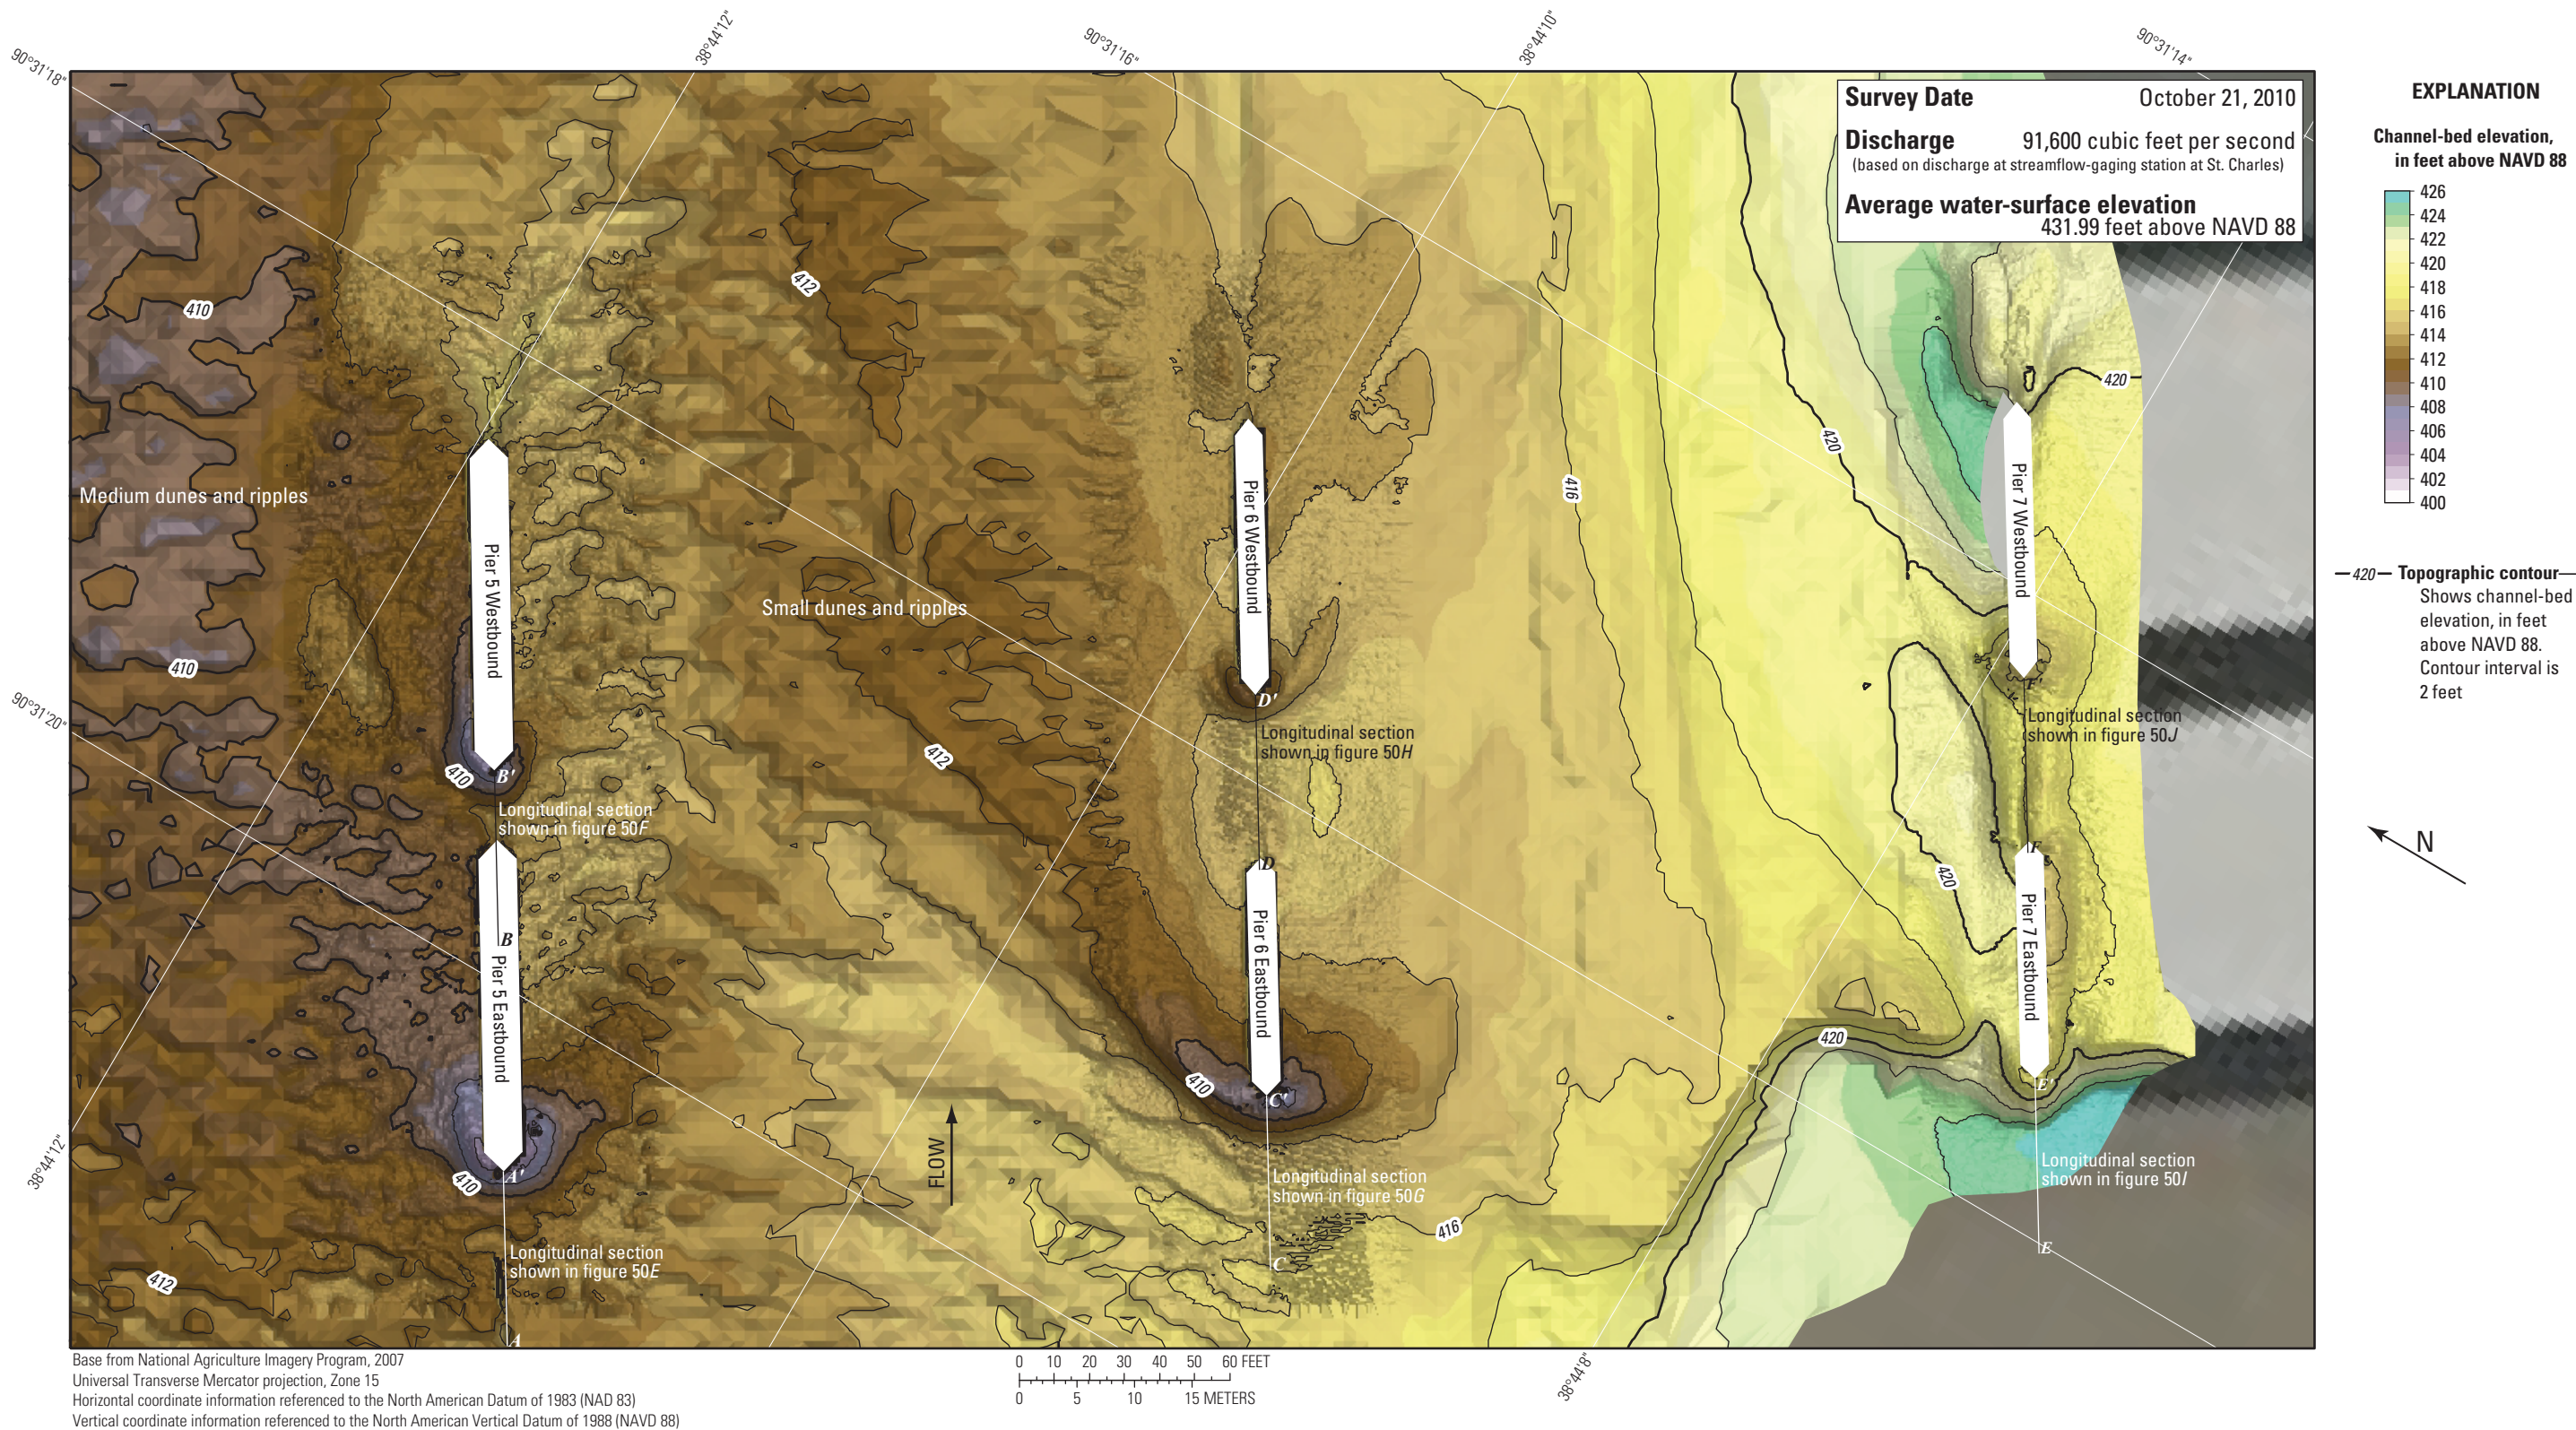
Scour holes were present in the vicinity of the main channel piers (fig. 14) of structure A5585, and generally there

was more substantial scour associated with the upstream (eastbound) piers than the downstream (westbound) piers. The scour hole at upstream (eastbound) pier 5 had a minimum elevation of about 405 ft (fig. 14; table 6), about 6 ft below the average channel bed immediately upstream from the pier, whereas the scour hole at downstream (westbound) pier 5 had a minimum elevation of about 406 ft (fig. 14; table 6), about 7 ft below the average channel bed immediately upstream from the pier. The scour hole at upstream pier 6 had a minimum elevation of about 408 ft (fig. 14; table 6), about 8 ft below the average channel bed immediately upstream from the pier, whereas the scour hole at downstream pier 6 had a minimum elevation of about 411 ft (fig. 14; table 6), about 5 ft below the average channel bed immediately upstream from the pier. The scour hole at upstream pier 7 had a minimum elevation of about 418 ft (fig. 14; table 6), about 7 ft below the average channel bed immediately upstream from the pier, whereas the scour hole at downstream pier 7 had a minimum elevation of about 415 ft (fig. 14; table 6), about 3 ft below the average channel bed immediately upstream from the pier.

Figure 14. Bathymetric survey of the Missouri River channel in the vicinity of the main channel piers of dual bridge structure A5585 on State Highway 364 near St. Louis, Missouri.
